AFTER ACTION REVIEW

2700 MIDDLEFIELD RD. 8 ALARM FIRE

JUNE 3RD, 2024

PRESENTED BY: MENLO PARK FIRE PROTECTION DISTRICT

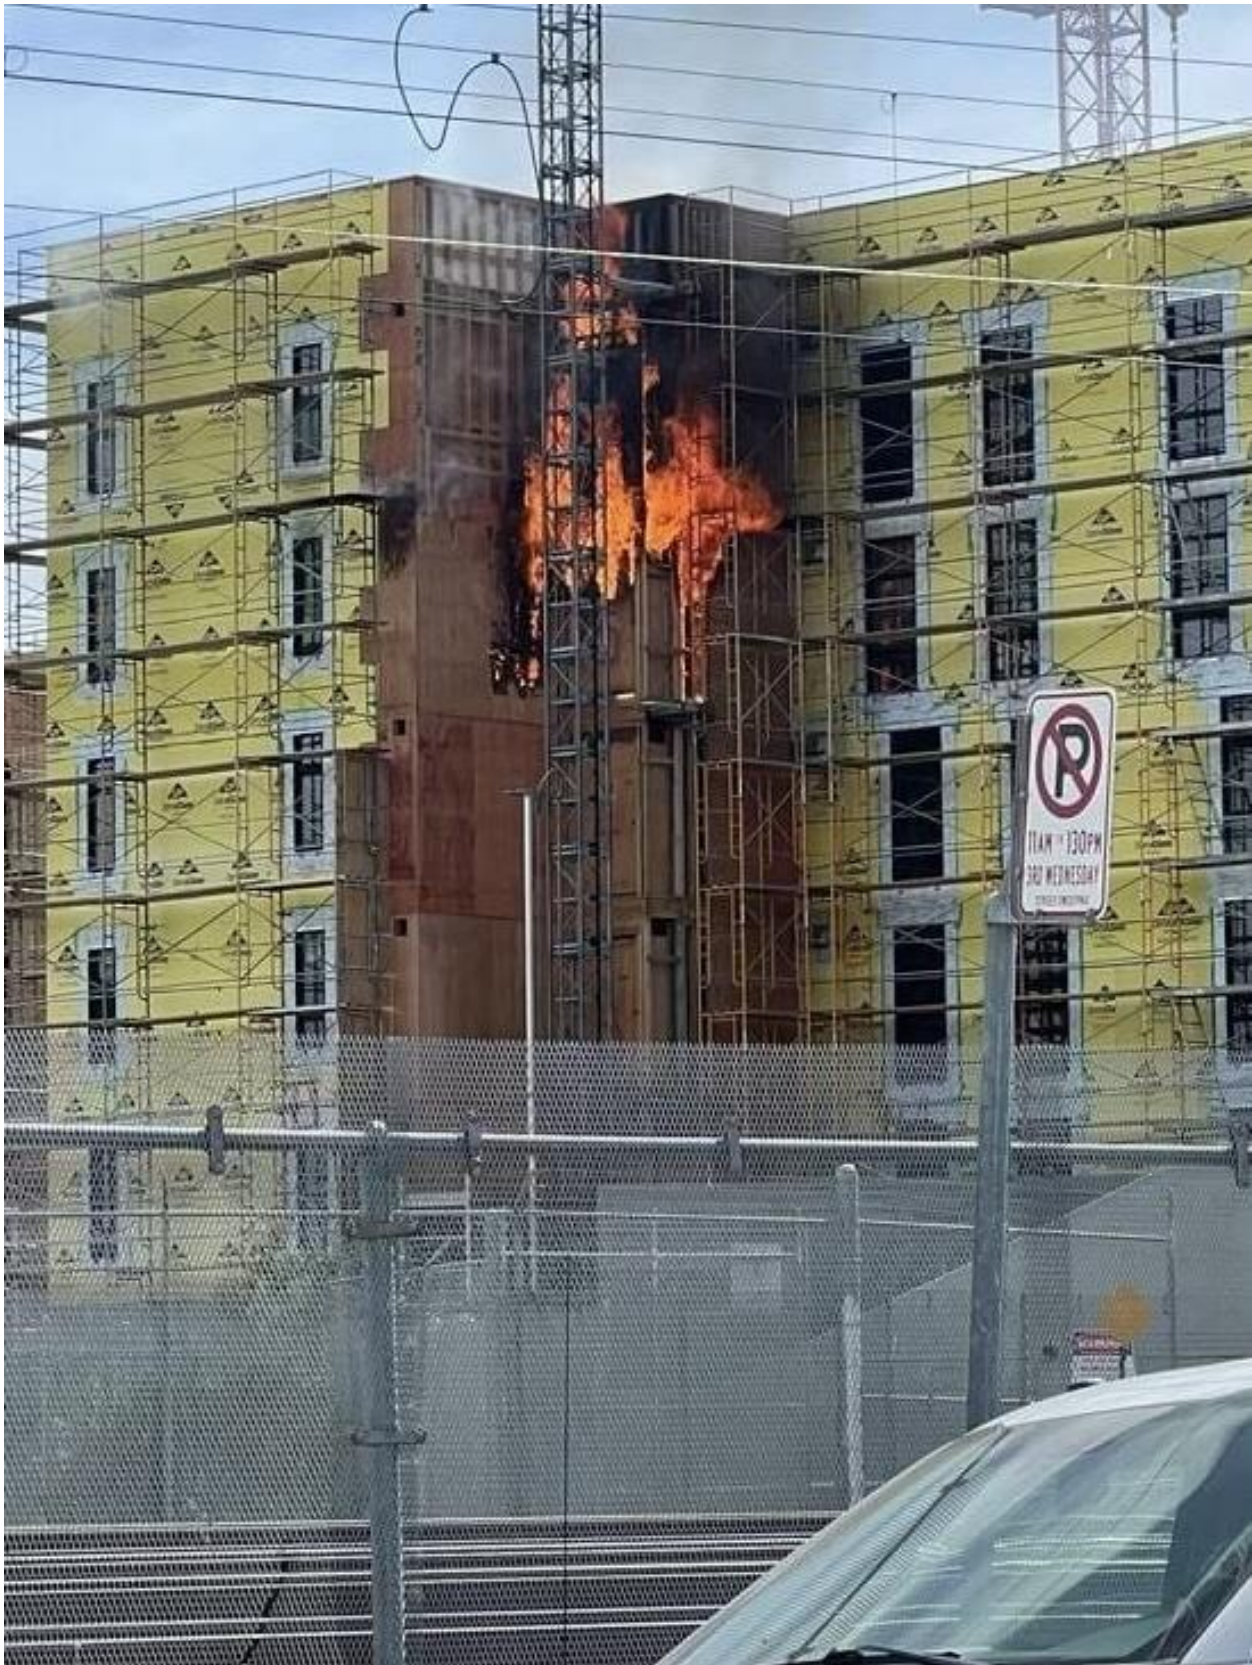
Figure 1. Fire conditions prior to the arrival of the first alarm assignment.

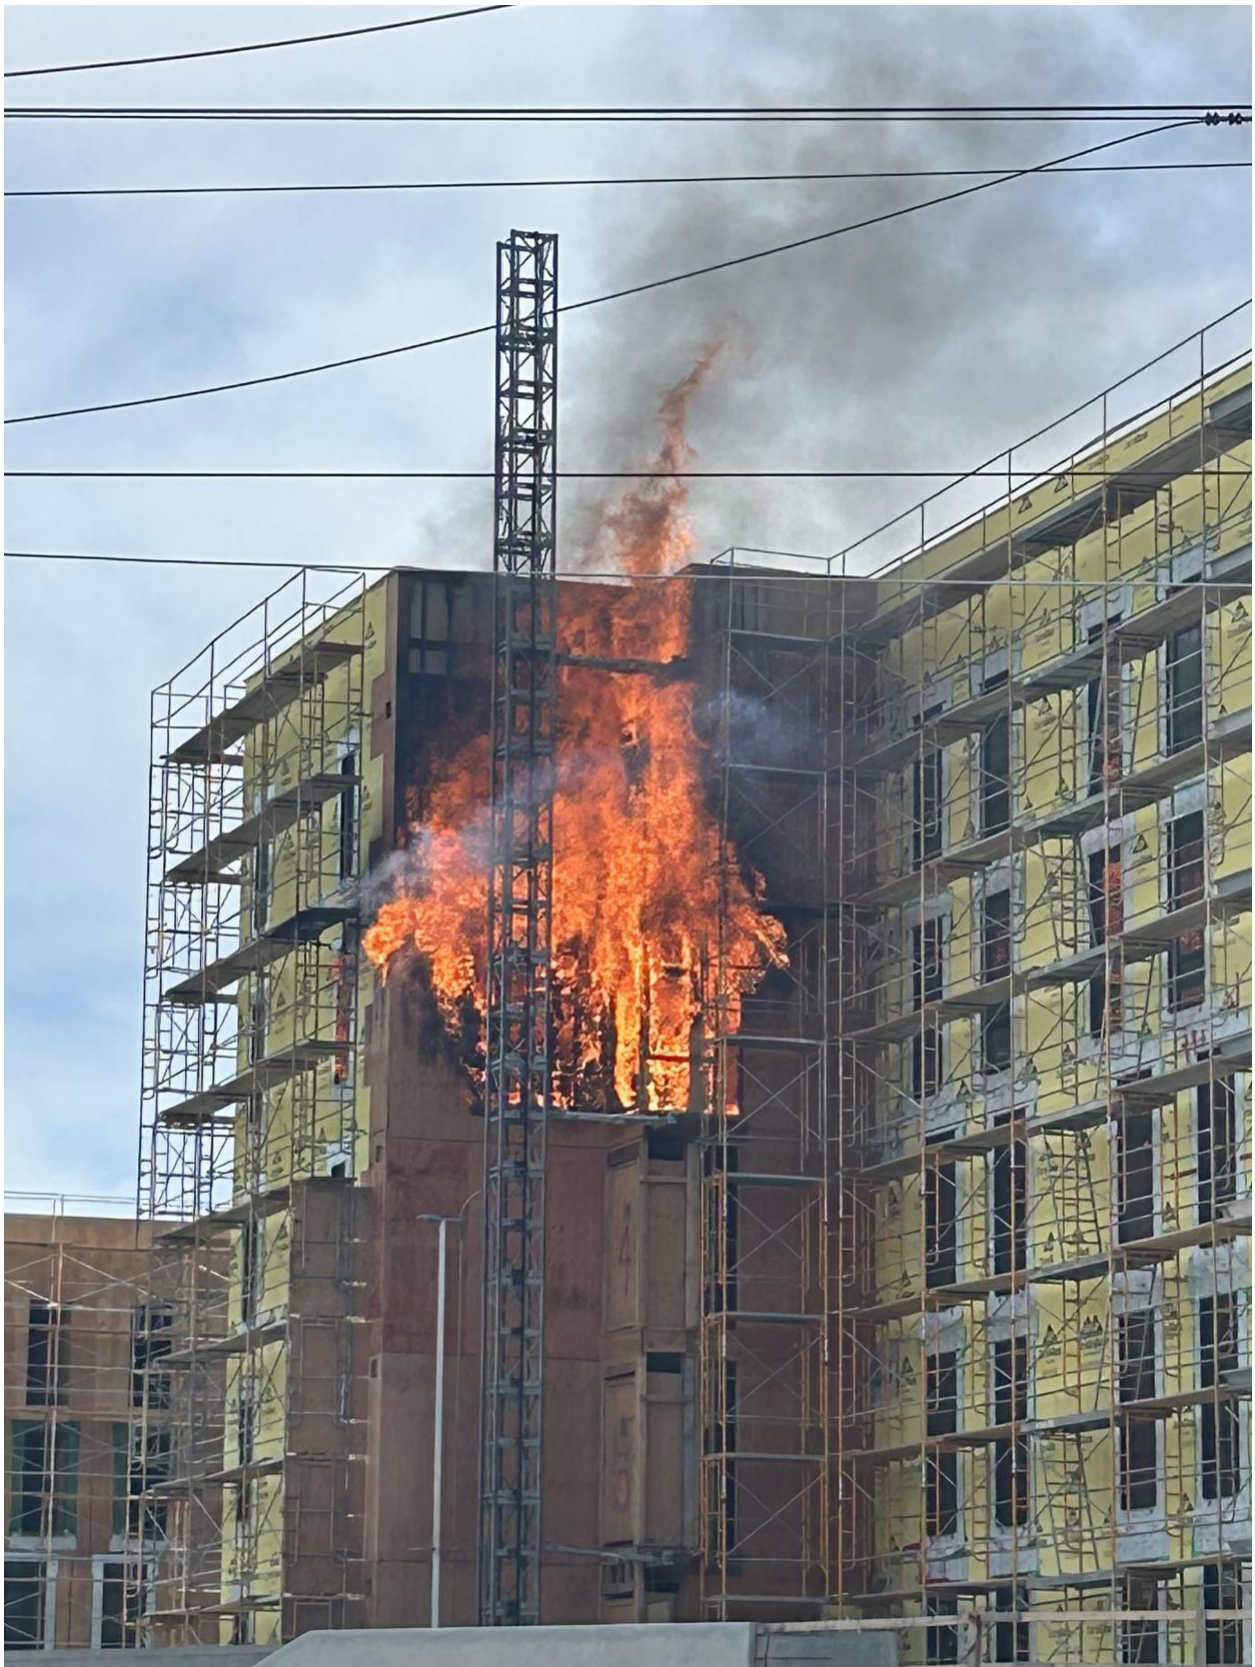
Figure 2. Fire conditions at the approximate arrival time of the first alarm assignment.

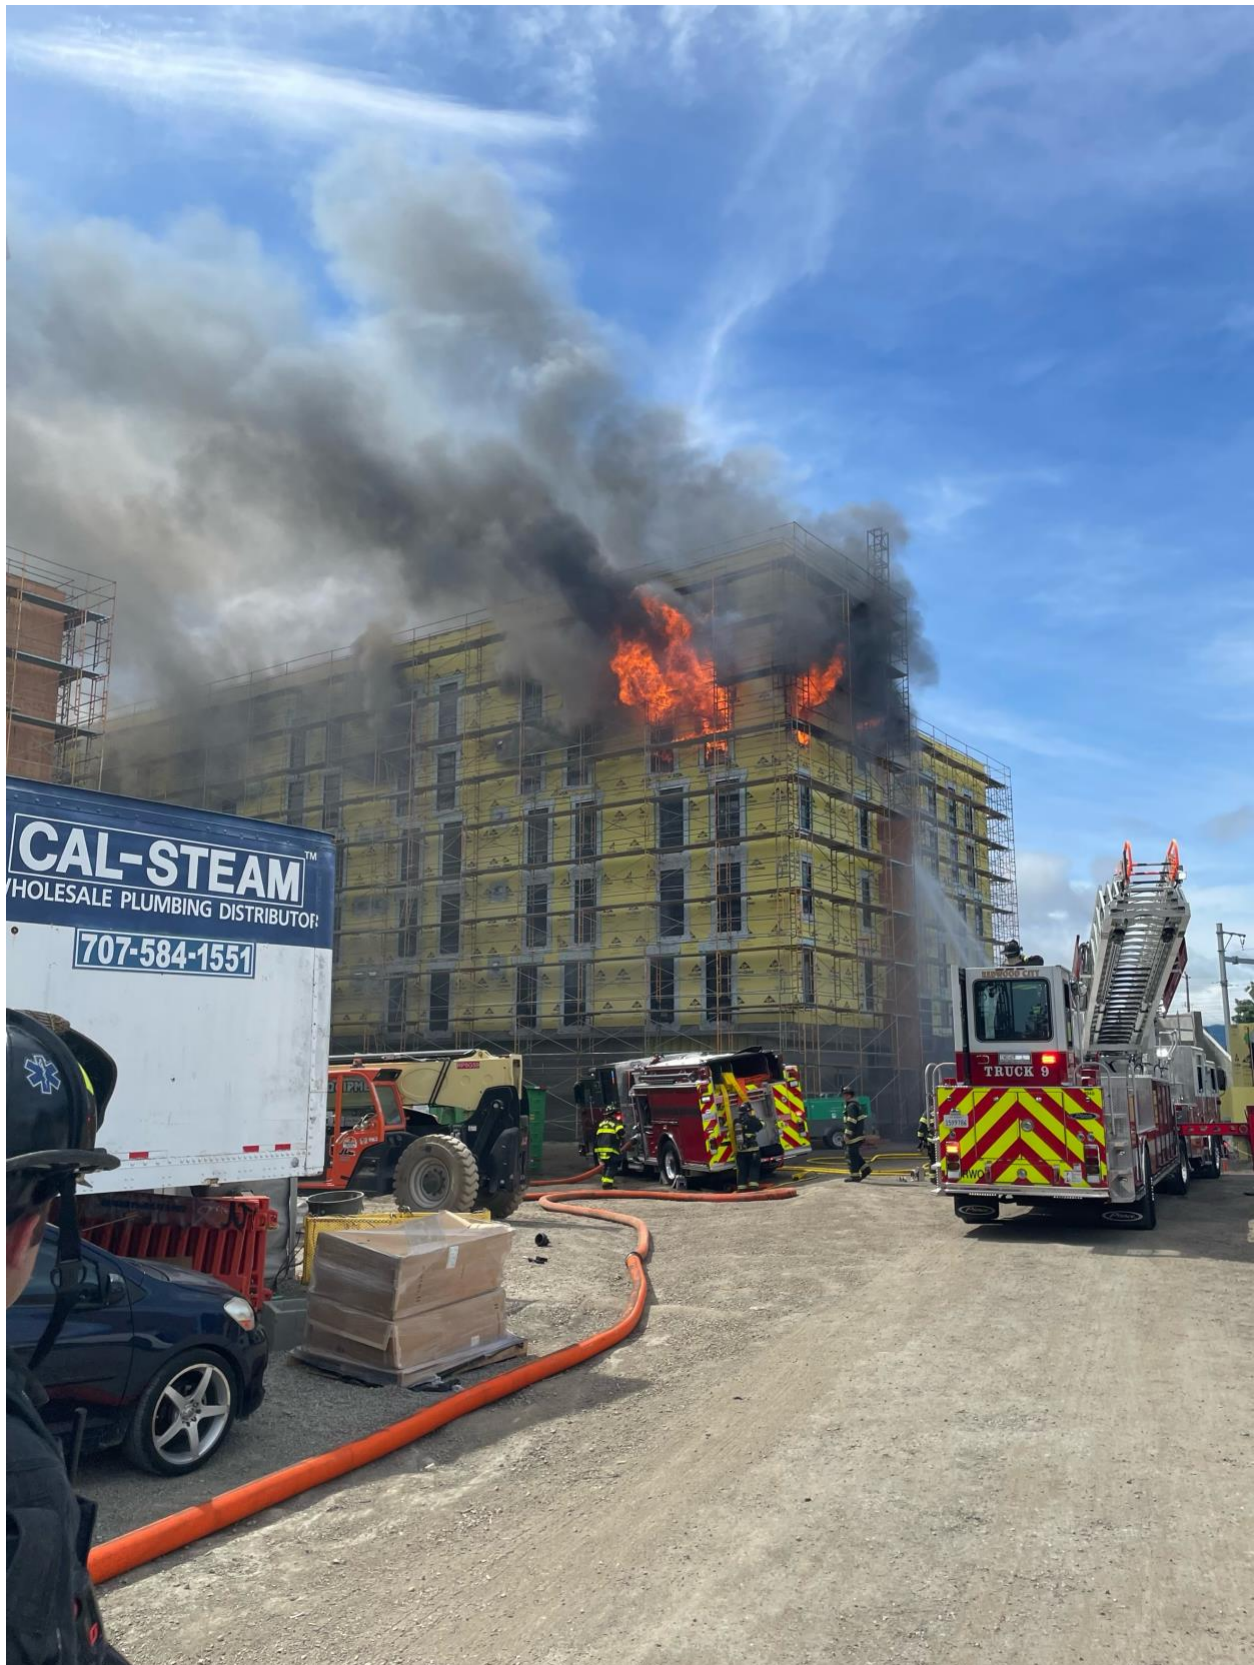
Figure 3. Fire conditions shortly after the arrival of the first alarm.

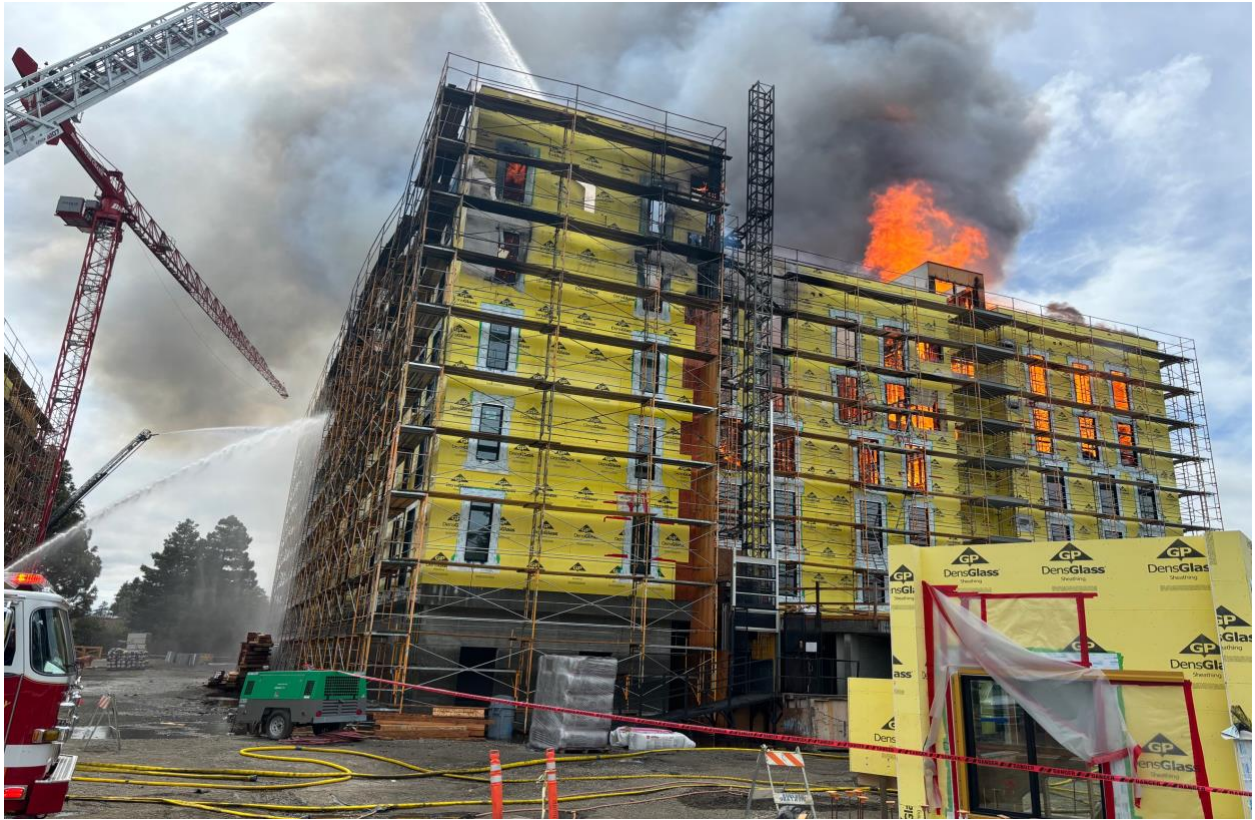
Figure 6. Middlefield Junction Building B.

Building B (*Figure 6*), the fire building, included 104 units totaling 171,706 square feet. Building B was a five-story over podium structure comprised of Type 3A over Type 1A construction for a total of six stories standing 65 feet in height. A temporary FDC feeding the standpipe was in place during the construction phase as required per the California Fire Code (*Figure 7*).

Building B was in what is commonly referred to as the ‘rough frame’ phase of construction. The contracted construction company bases its schedule on phases, whereas each contractor would have the availability to areas based on the location and access of the materials being installed. The internal wood framing, exterior siding, windows, and roofing were being completed to provide environmental protection suitable for other trades to continue their work inside the building in a weather-safe and code-compliant environment. Items being hung or attached to the uppermost parts of the structural framing go first, which then allows the next trade on the schedule to perform their work with clearance, location, and priority in relationship to the timeline of the job. At the time of the fire, the project was in the process of completing the

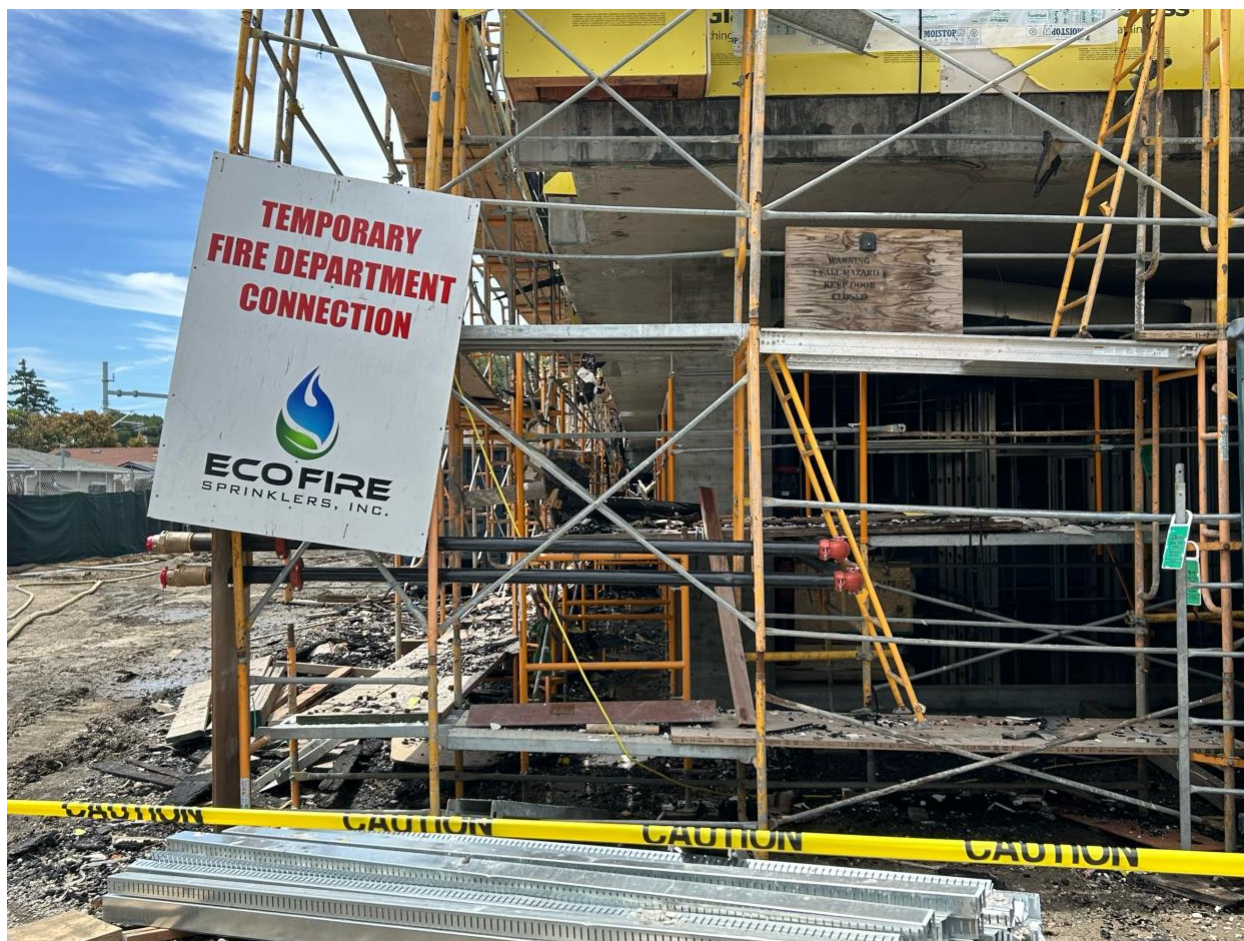
Figure 7. Temporary FDC for Building B located at the Alpha/Bravo corner.

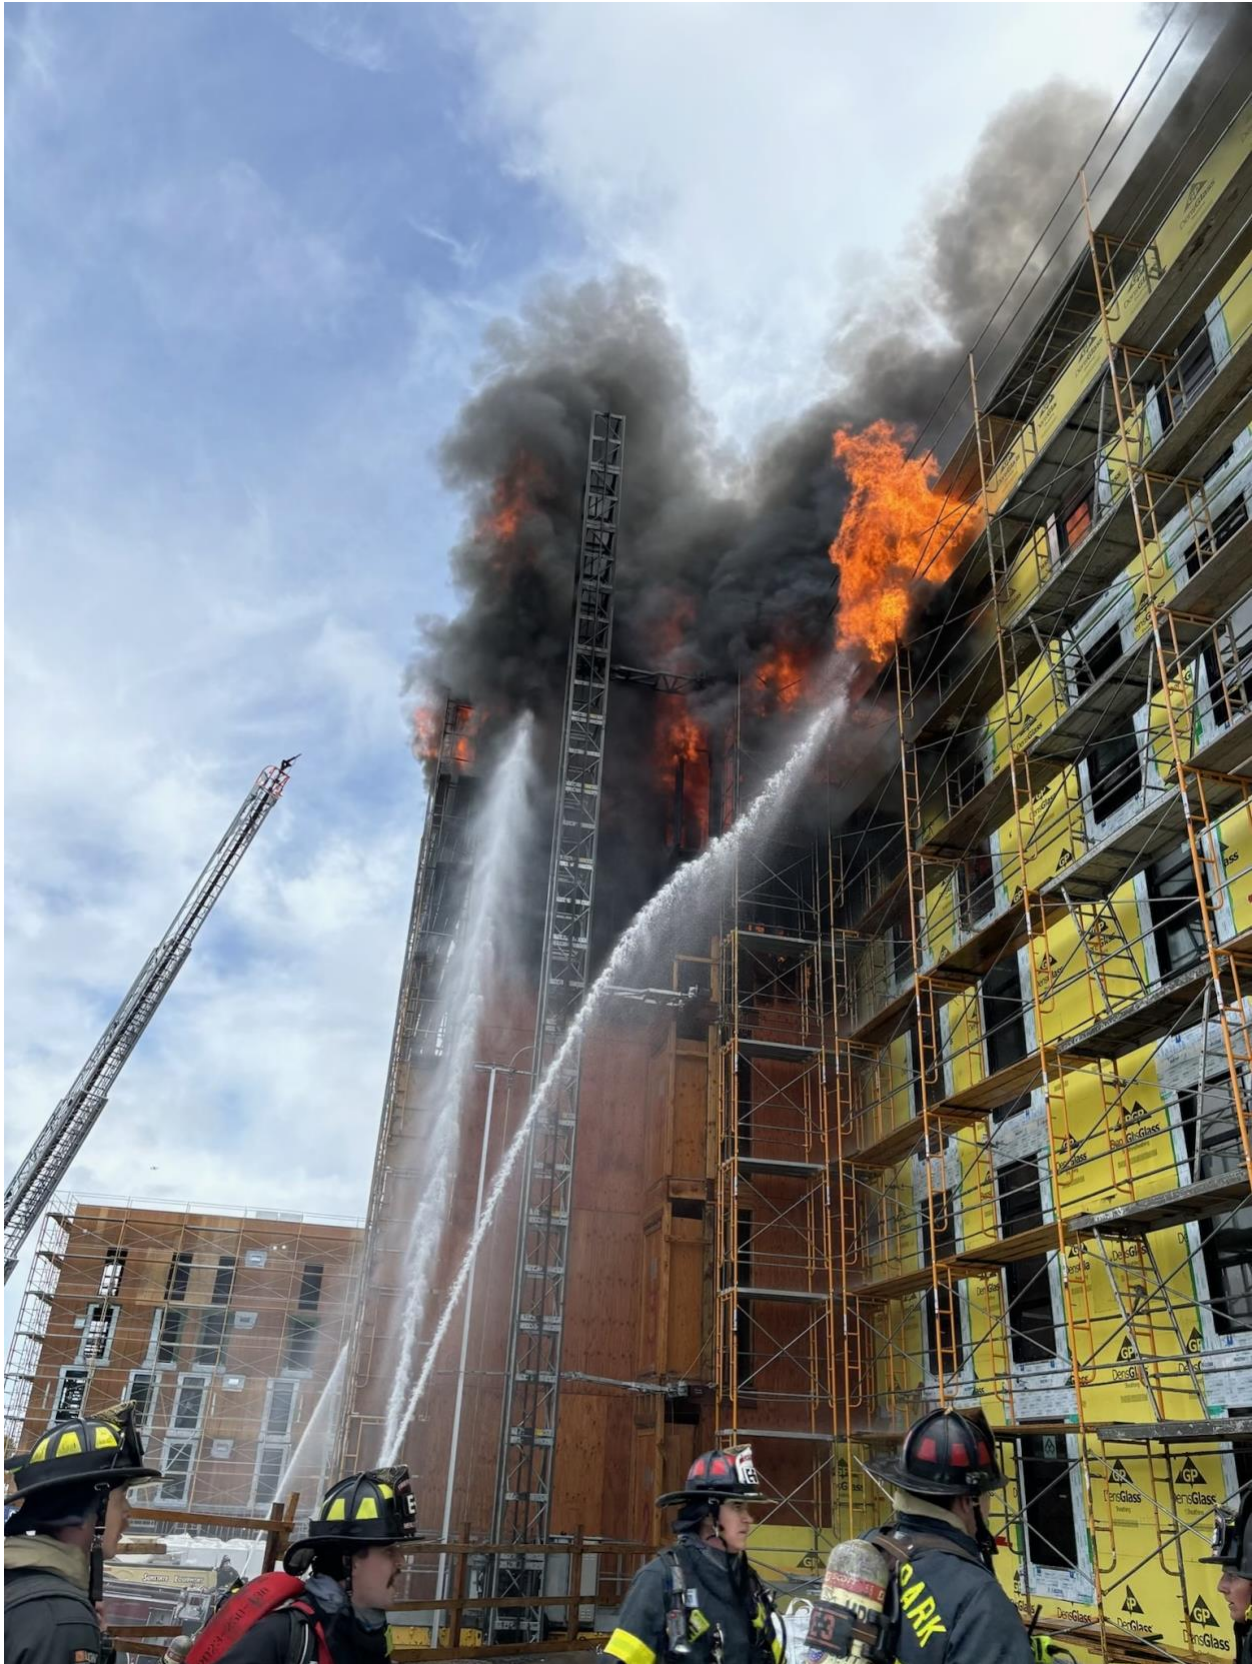
Meanwhile, fire companies were advancing handlines up to the podium on the Delta side and initiating a fire attack from the structure's exterior (*Figure 12*) while Engine 3 was deploying its master stream deck gun on the Alpha side. This exterior fire attack attempted to keep the fire contained to the Alpha/Bravo corner of the building. Following approximately 10 minutes of exterior fire attack from the Alpha and Delta corners, Division 5 made the determination that the fire was rapidly advancing down the Alpha and Delta sides of the structure, and for safety reasons and potential building collapse, all personnel needed to be removed from the vicinity of the building. All handlines on the Delta side podium were abandoned, and fire personnel moved away from the structure and prepared for defensive operations.

Figure 12. Initial exterior fire attack efforts towards Division 5 from the Delta side podium.

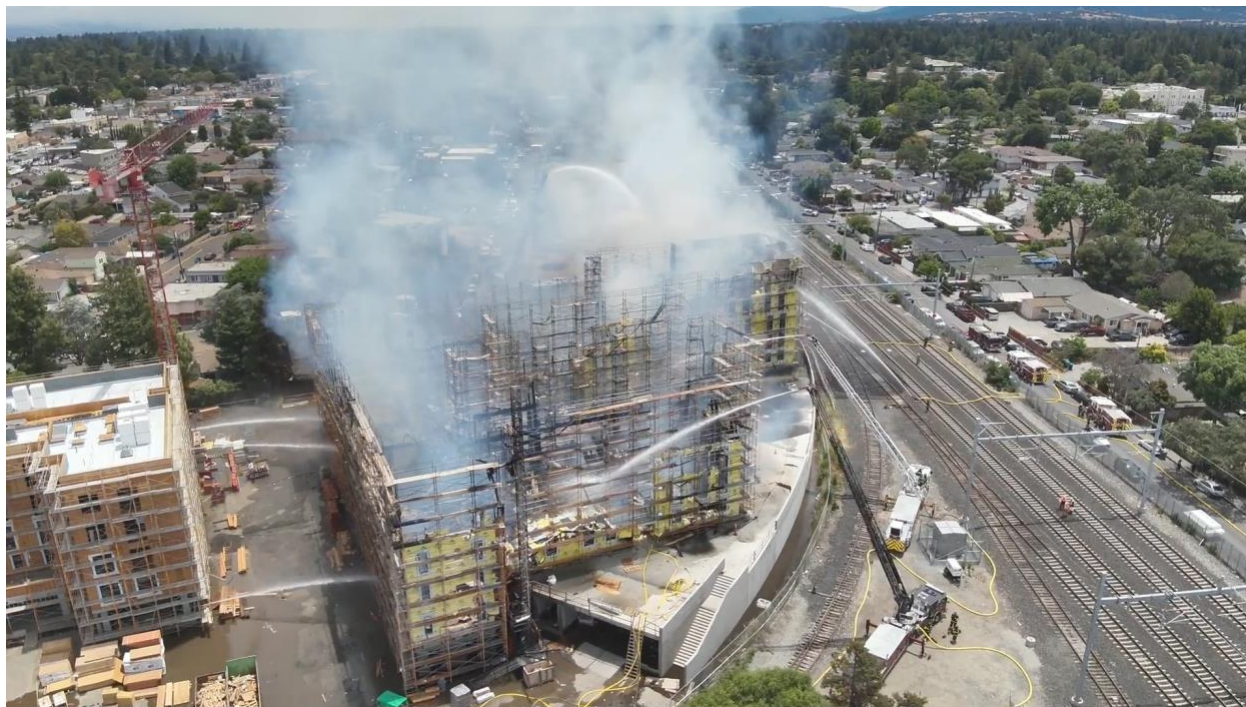
The Alpha Exposure Division was assigned to CH3B (BC Lax). Engine companies were positioned inside Building A with multiple handlines directed towards Building B (*Figure 18*). This was a critical operation as it was key in preventing Building A from becoming involved.

Figure 18. Alpha Exposure Division operating 3 handlines from Building A (left) onto Building B (right).

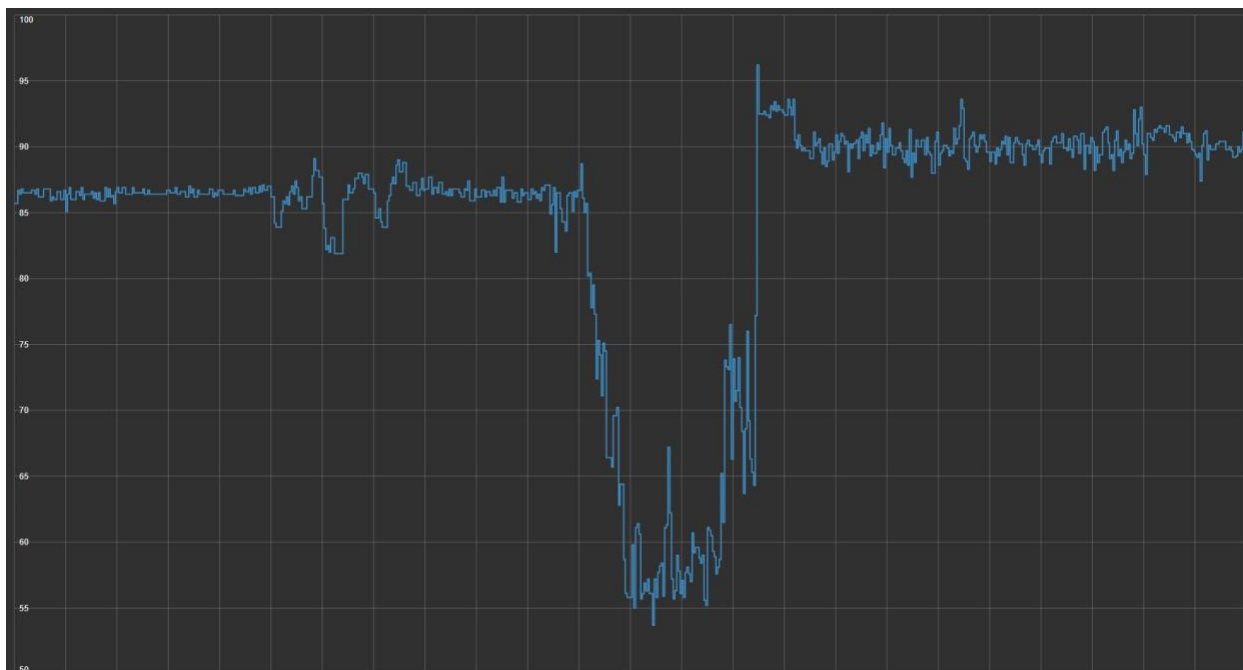
Following notification that the fire had been contained, Cal Water personnel monitored the system and started to restore the regulators to their normal settings. Two hydrants could not be shut down due to mechanical failure and operator error, requiring Cal Water to respond. This meant that engine companies could not disconnect and retreat, possibly affecting evacuations and/or apparatus access. After Cal Water responded to these locations, it was determined that one hydrant was not shut off due to operator error, and the other one needed Cal Water personnel to operate the valve at the street to shut it down. Cal Water reported that there was no damage to any of the water mains as a result of the total demand on the system.

Figure 22. Pressure readings at one of the Cal Water SFPUC connections on June 3rd illustrate the pressure drop when engines started pulling from the hydrants. Cal Water raised pressure to accommodate more flow once they saw the decrease in pressure. Image provided courtesy of the California Water Service.

6. For large-scale fire incidents, take the time to spot apparatus for current and future fire conditions and apparatus usage.
7. Notify the water company early when there will be a significant demand on the water supply system so they can increase the pressure. Conversely, notify them when operations are winding down so they can decrease the pressure to avoid damage to water mains and valves.
