AFTER ACTION REVIEW

2700 MIDDLEFIELD RD. 8 ALARM FIRE

JUNE 3RD, 2024

PRESENTED BY: MENLO PARK FIRE PROTECTION DISTRICT

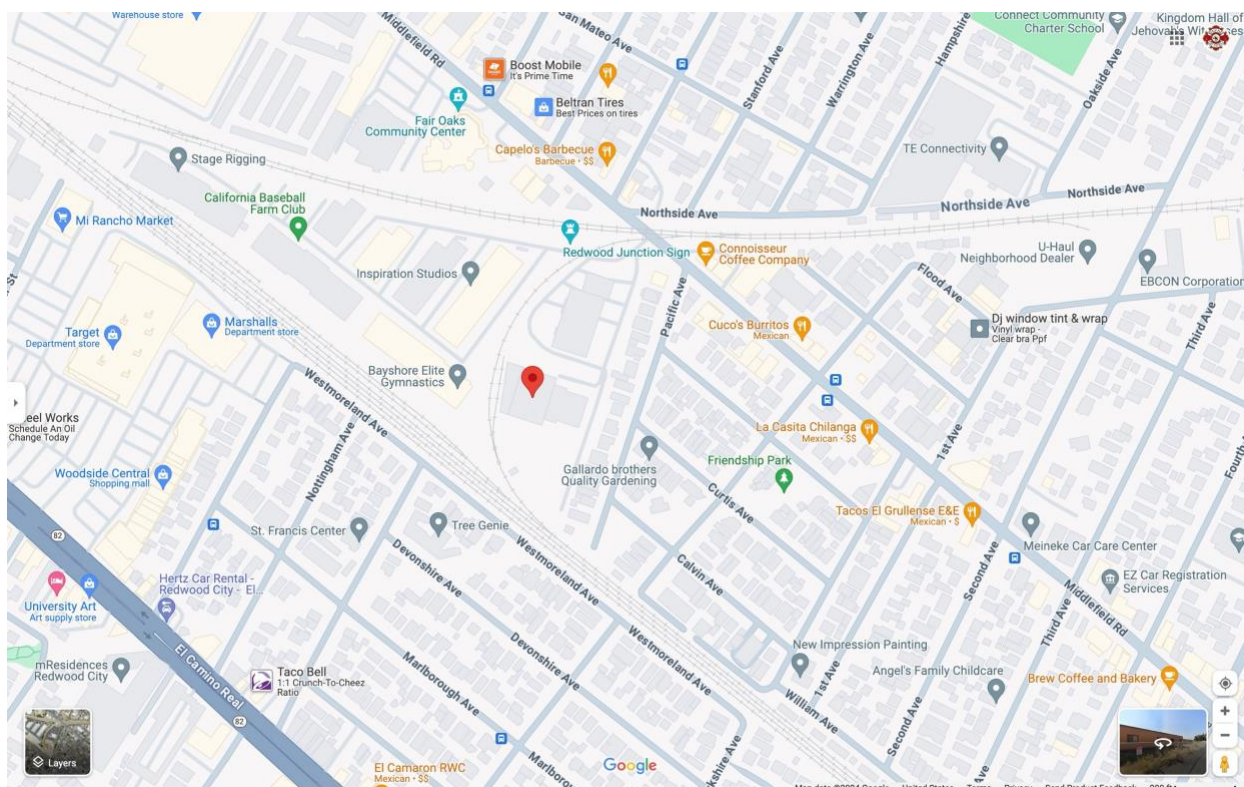
Figure 4. Google Maps shows the location of the incident and the surrounding vicinity.

The Middlefield Fire occurred at 2700 Middlefield Rd. in the North Fair Oaks community of Redwood City, CA. (*Figure 4*). The property, known as Middlefield Junction, is accessed from Middlefield Rd. at the San Mateo County Fair Oaks Health Clinic entrance. Residential neighborhoods are located to the north, south, and east, with industrial buildings to the west of the incident site. Middlefield Rd. is the main roadway to the north, and the Caltrain railroad lies along the property's southwest edge. Building B, the fire building, sits on the southernmost end of the property, and Building A, the unaffected building, is located directly to the north. San Mateo County's Fair Oaks Health Clinic is located to the north of Building A (*Figure 5*).

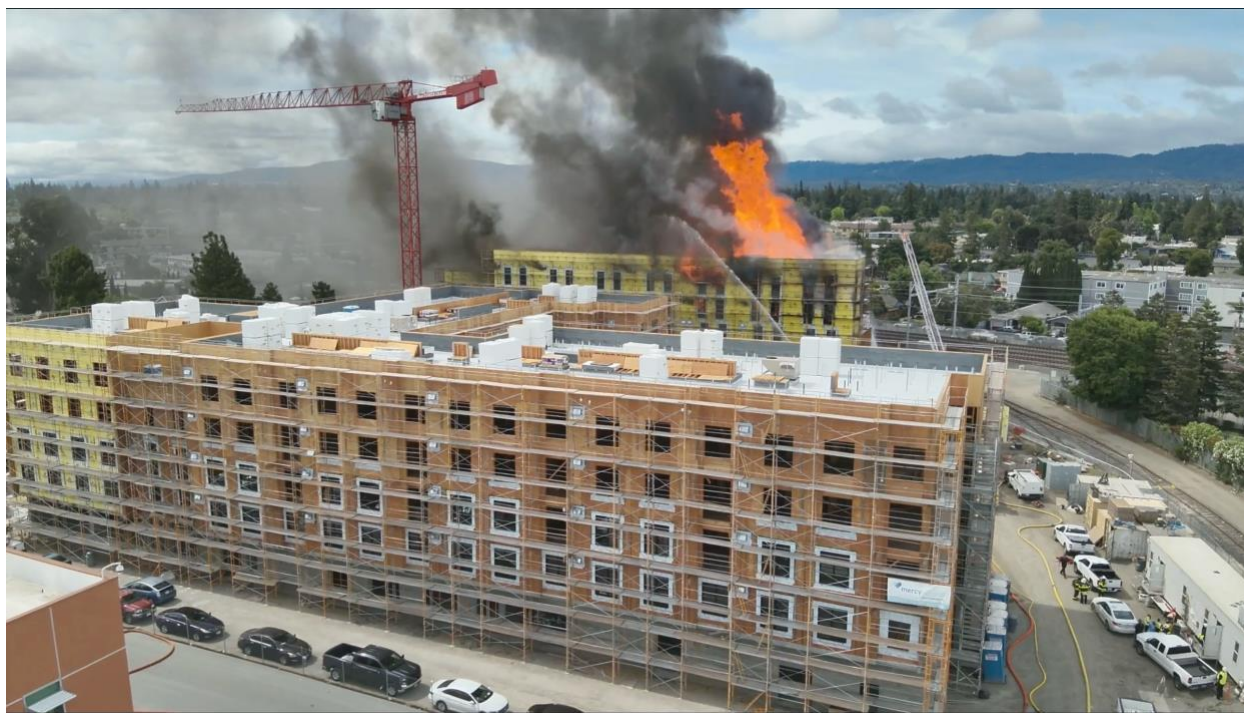
Figure 8. Middlefield Junction Building A.

Building A (*Figure 8*), the unaffected building, is located directly to the north of Building B and was designated as the Alpha Exposure Division during the incident. Building A included 75 units totaling 104,282 square feet. Building A is a four-story over podium structure comprised of Type 5A over Type 1A construction for a total of five stories standing 55 feet in height. A temporary FDC feeding the standpipe is in place during the construction phase as required per the California Fire Code.

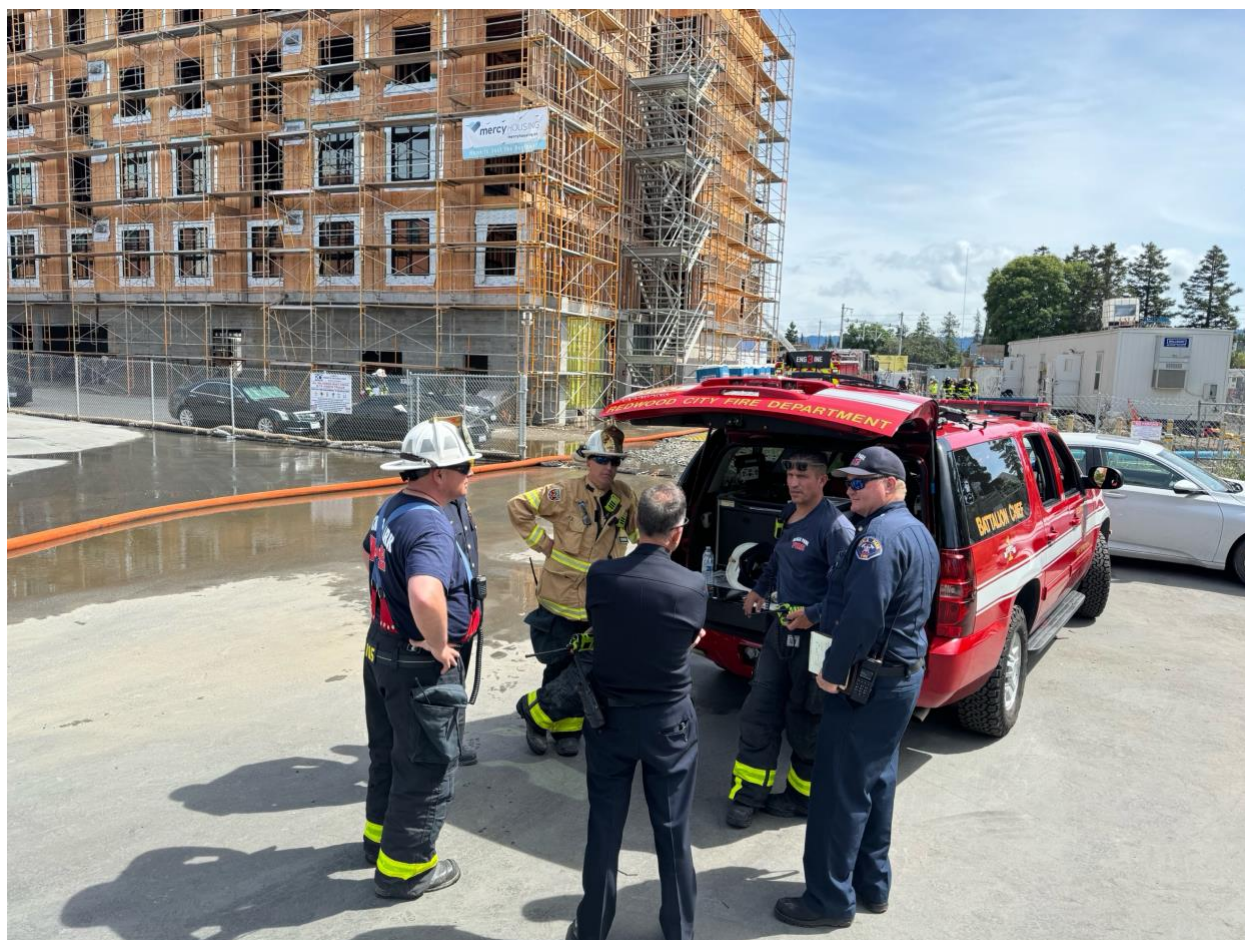
Figure 10. Incident Command Post.

Incident Command (IC) was initially established by Engine 3 upon their arrival on scene and then assumed by Battalion 3 (BC Balton) upon his arrival. The Incident Command Post (*Figure 10*) was located in the southwest corner of San Mateo County's Fair Oaks Health Clinic parking lot at 2700 Middlefield Rd. Recognizing the potential magnitude of the incident, Battalion 3 assigned Battalion 101 (BC Martin) as the Deputy Incident Commander. Battalion 3 and Battalion 101 identified that information and communications were coming into the ICP rapidly, which was proving to be unmanageable for one IC to safely and effectively handle alone. The IC and Deputy IC divided command responsibilities for radio traffic, resource assignment, and resource tracking, and, as a team, effectively managed all resources and radio communications (see *Figure 11* for the ICS organizational chart).

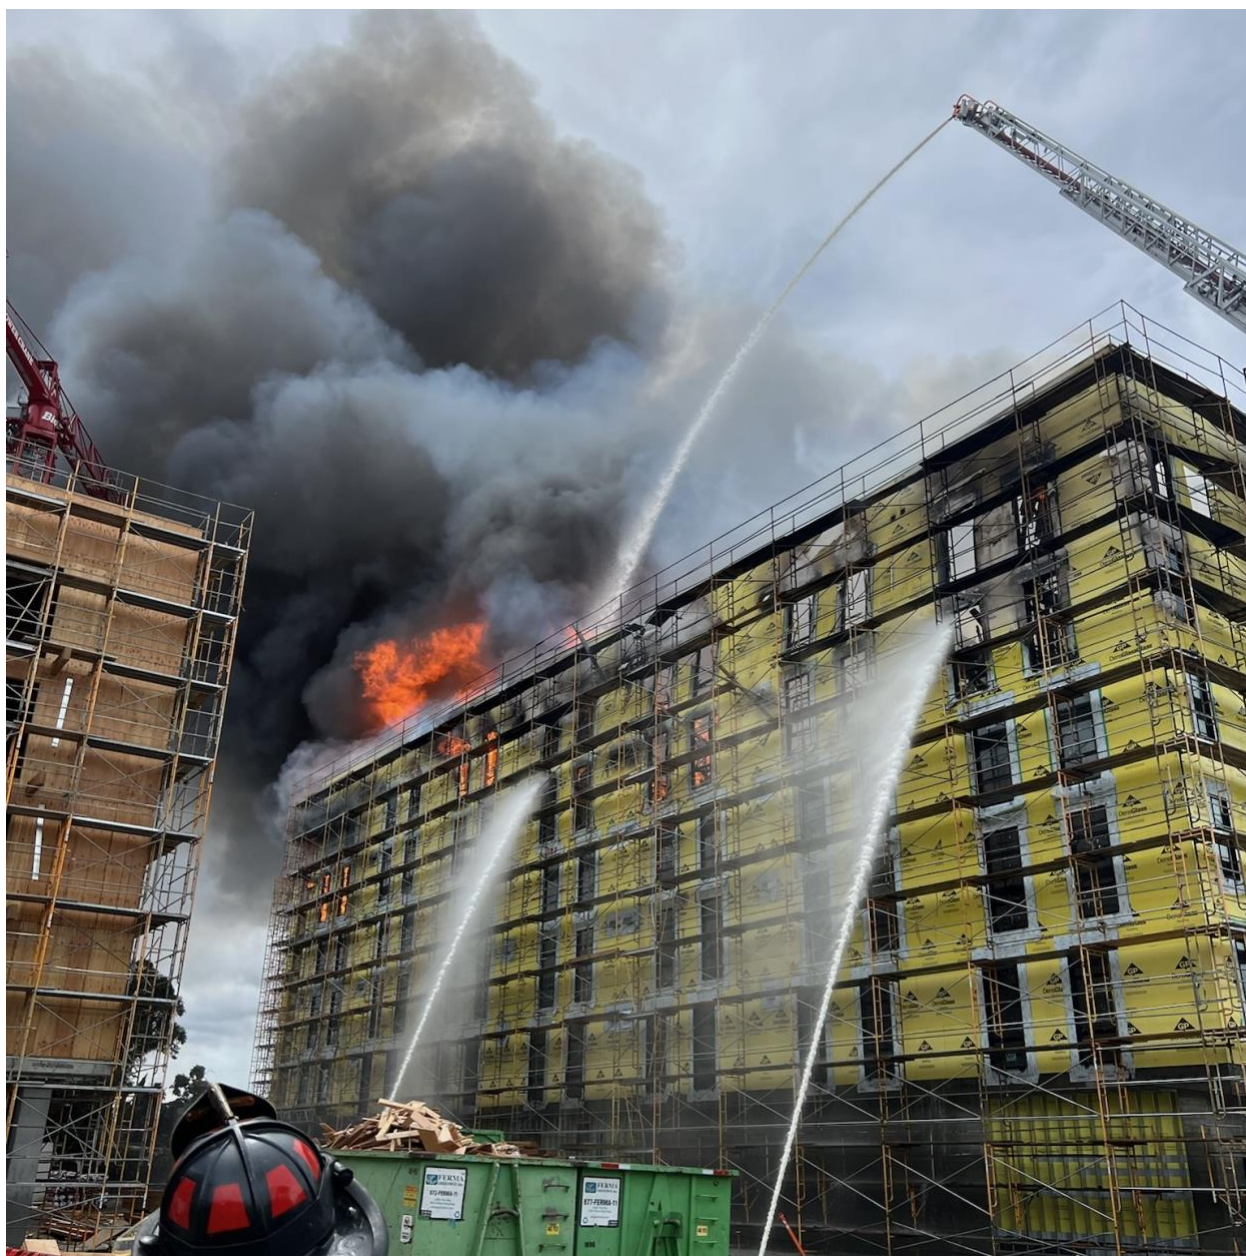
Figure 13. Division Alpha.

Following the decision to transition from an offensive to a defensive strategy, Division 5 was dissolved and Division Alpha was established by Battalion 1. Division Alpha coordinated defensive fire attack operations on the Alpha side of the building (*Figure 13*) and then along the Delta and Charlie sides until Division Delta was established. Ultimately, there were three aerial master streams and four ground monitor master streams in operation in Divisions Alpha, Charlie, and Delta.

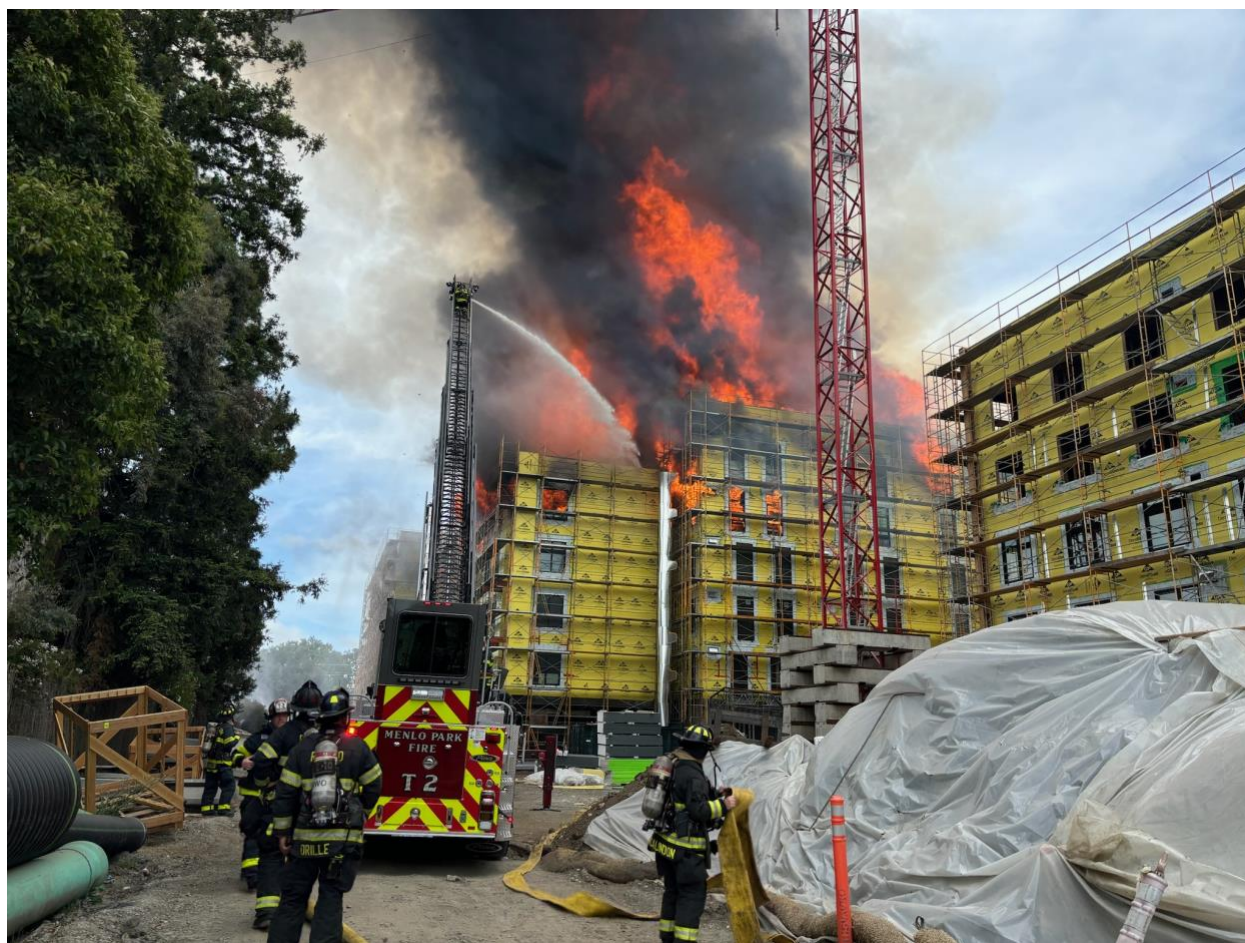
Figure 14. Division Bravo from the Alpha/Bravo corner.

Division Bravo (*Figure 14*) was assigned to Battalion 2 (BC Douthit) with an operational objective of a defensive fire attack on the east side of Building B to prevent extension into the adjacent residential neighborhood. This division would become one of the top operational priorities of the incident as it posed the greatest direct exposure threat to residential homes. Aerial master streams, ground monitor master streams, and 2 ½" handlines were utilized to hold the fire to the building of origin and prevent extension to the adjacent homes.

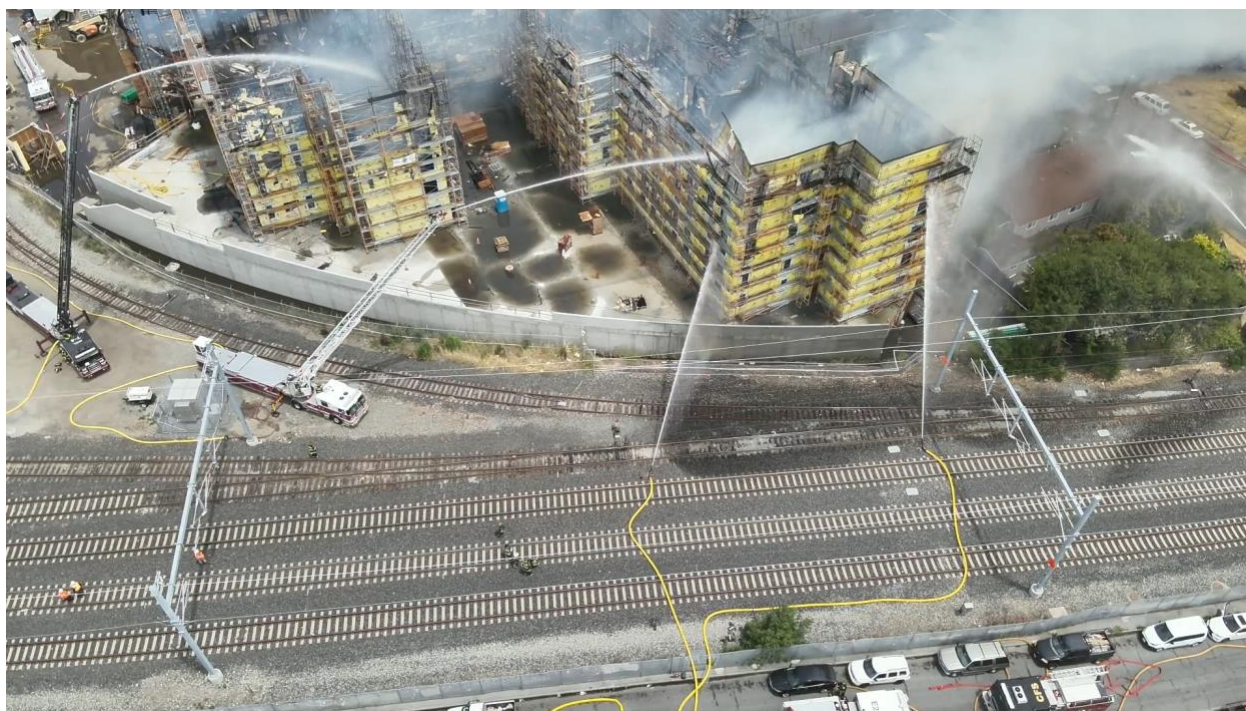
Figure 15. Division Charlie

Division Charlie (*Figure 15*) was never assigned a division supervisor; however, this side of the building was covered by Division Alpha and Division Delta throughout the incident. Division Charlie was the structure's south side along the Caltrain railroad tracks. In this division, one truck company operated an aerial master stream, and two engine companies supplied ground monitor master streams from hydrants located on Westmoreland with supply lines laid across the railroad tracks. Prior to operating in this area, all train services needed to be stopped by Caltrain and PG&E de-energized the high voltage OCS lines for the safety of fire personnel operating in this division.

5. Eliminating power to the Caltrain high-voltage OCS power lines was critical for gaining access to the Charlie side of the structure and initiating master stream operations on and around the railroad tracks directly underneath and near those power lines. The request to de-energize the OCS lines could have been made sooner and early identification of this hazard is critical.

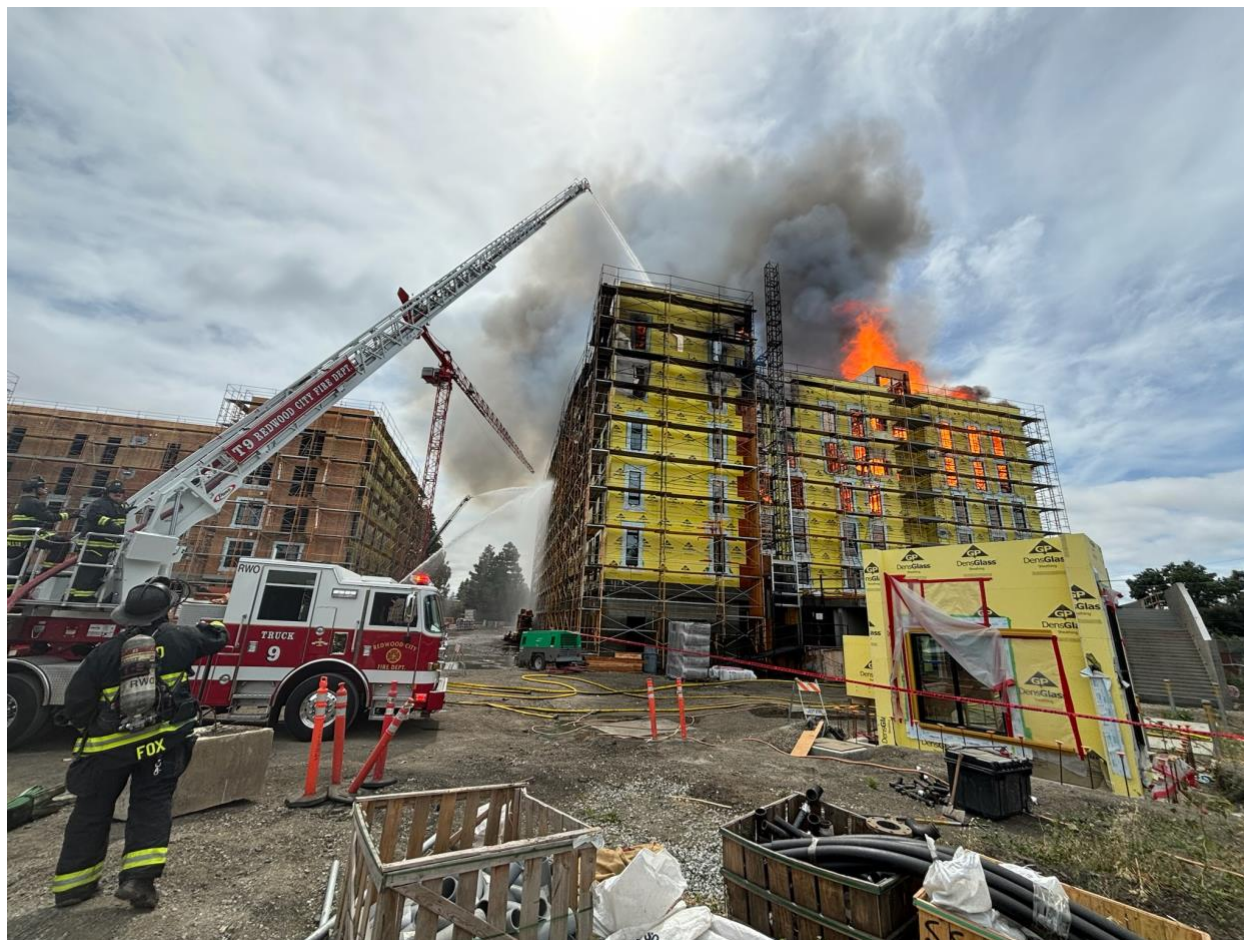
Figure 16. Division Delta.

Division Delta (*Figure 16*) was assigned to Battalion 11 (BC Pino) as the fire progressed and Division Alpha was outside his span of control and thus unable to adequately supervise both divisions and all of the assigned resources working in those areas. Division Delta supervised Charlie and part of the Delta sides of the structure and shared some resources with Division Alpha. Division Delta established and supervised multiple master stream appliances that attempted to suppress the fire on the Charlie side and prevent it from progressing to the Bravo side.

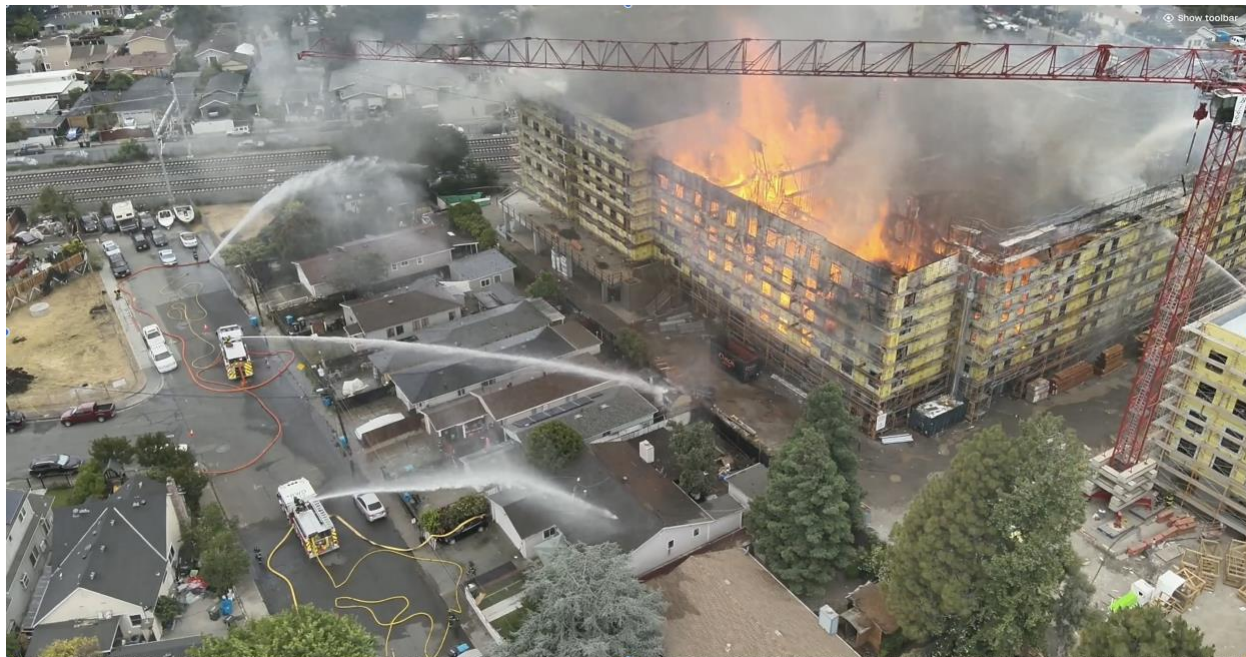
The Community Protection Group was assigned to Battalion 5 (BC Thorne) with the primary objective of protecting structures in the neighborhoods directly to the east and southeast of the main fire behind Division Bravo (*Figure 17*). Multiple master stream appliances were put in place along Pacific Ave. to protect homes from the radiant heat from the Bravo side while engine, truck, and squad companies conducted tactical patrols of the neighborhood and extinguished multiple spot fires as they ignited. The geographic area was defined as Pacific Ave., to the Caltrain tracks, to Middlefield Rd., to Berkshire Ave.

Figure 17. Community Protection Group performing structure defense on Pacific Ave.

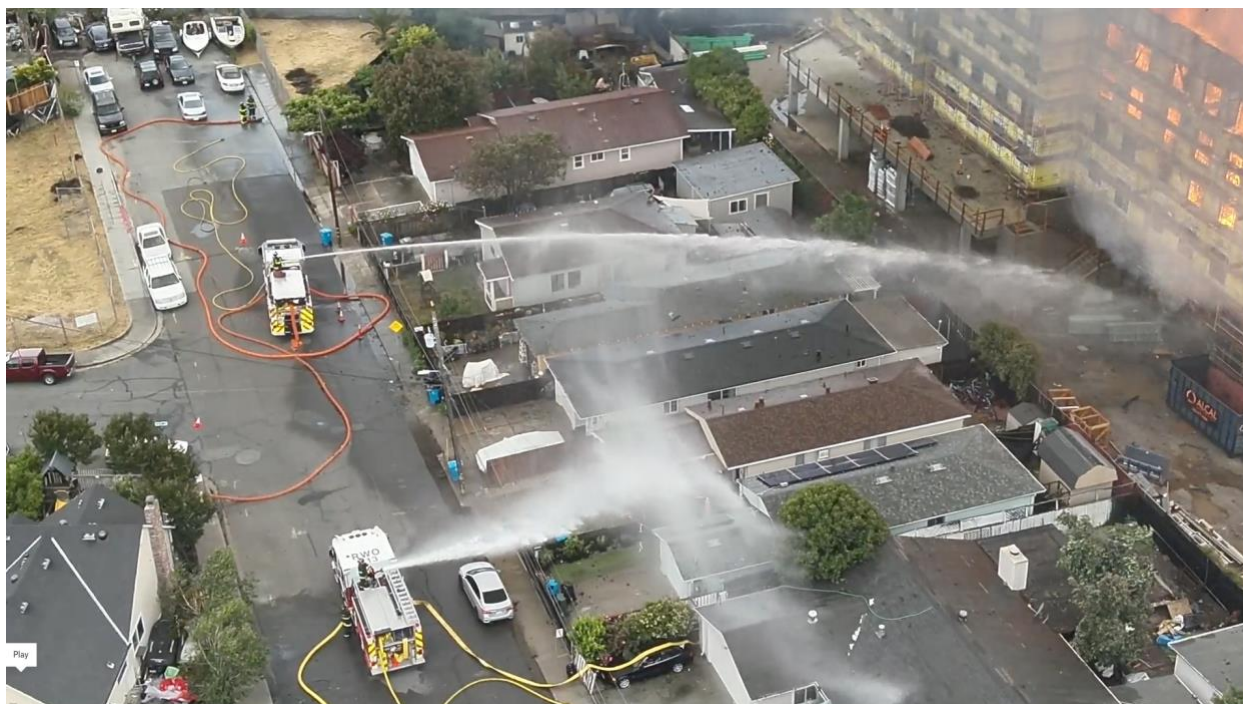
As the Middlefield Fire grew in size and intensity and began progressing through Building B toward the residential neighborhoods to the east, evacuations were initiated and fire suppression efforts focused heavily on protecting residential structures and properties (*Figure 20*). A total of 18 residential properties reported impacts as a direct result of the main fire. These impacts involved small grass fires, fence fires, broken windows, Gazebo damage, stairway damage, shed fires, roof damage, tree fires, vehicle damage, and damaged outside items. There were two vacant lots where small spot fires ignited, which were quickly extinguished. The Community Protection Group successfully prevented any residential structure fires from occurring as a result of exposure to the main fire.

Figure 20. Residential structure defense on Pacific Ave.

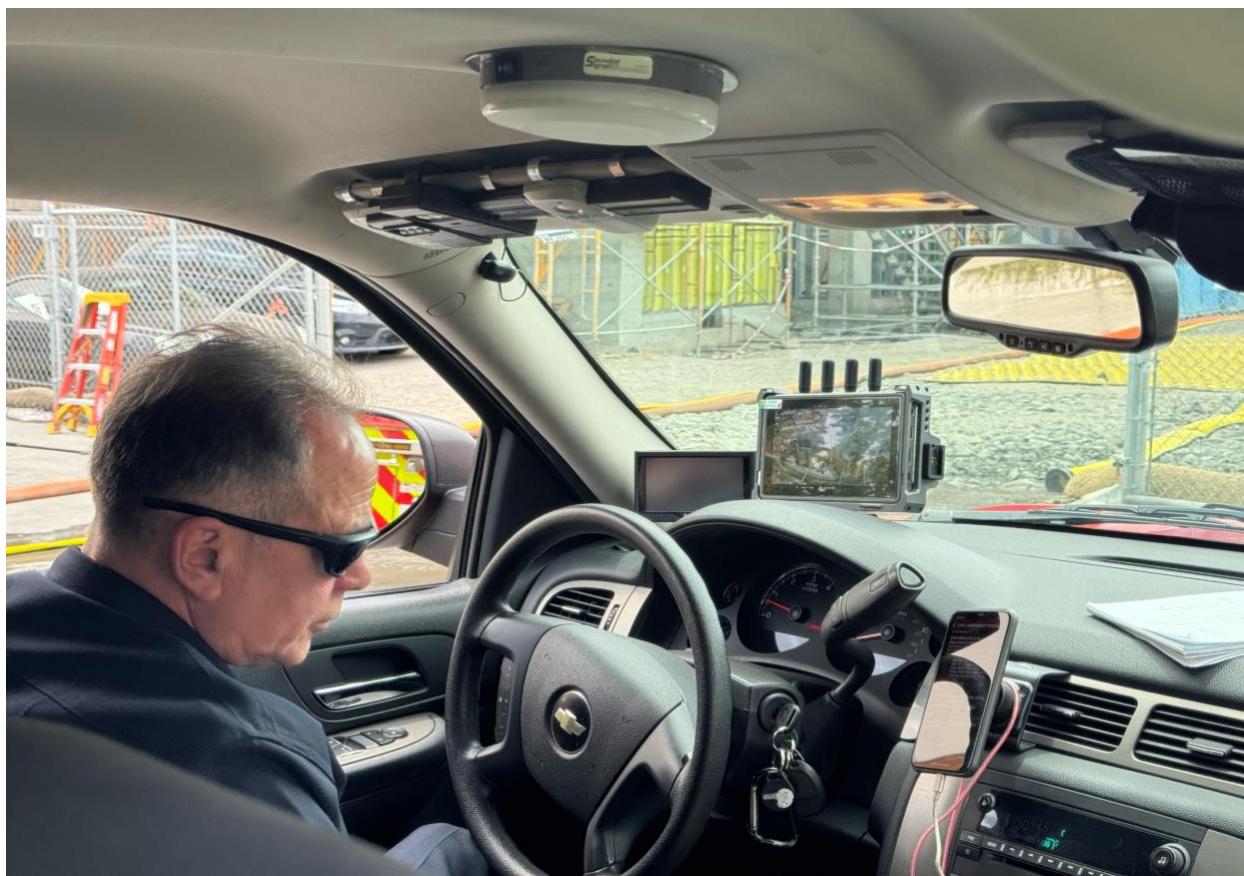
Upon arrival, MPFD UAS-1 met with the SMCSO pilot, who was already operational with their UAS, and a deconfliction plan was developed. Collaborating with the RCFD pilot, a coordinated plan was formulated among all UAS pilots to provide uninterrupted aerial overwatch flights. Live video footage and high-resolution thermal imaging were streamed to the ICP and the utilization of two fire agency UAS pilots allowed for constant aerial coverage of the incident scene. The aerial footage from the blended UAS team greatly augmented the situational awareness of the IC and enhanced the safety of the personnel at the scene and the safety of the surrounding neighborhoods and residents. In the subsequent days, multiple UAS flights were conducted by various MPFD UAS pilots to direct master streams, identify hot spots, conduct interior inspections of the parking structure, and document the incident scene.

Figure 21. Middlefield IC equipped with real-time overhead UAS imagery from a DJI HDMI wireless monitor.
